Z100F FLOFORCE™ IMPROPER ROOF MEMBRANE INSTALLATION

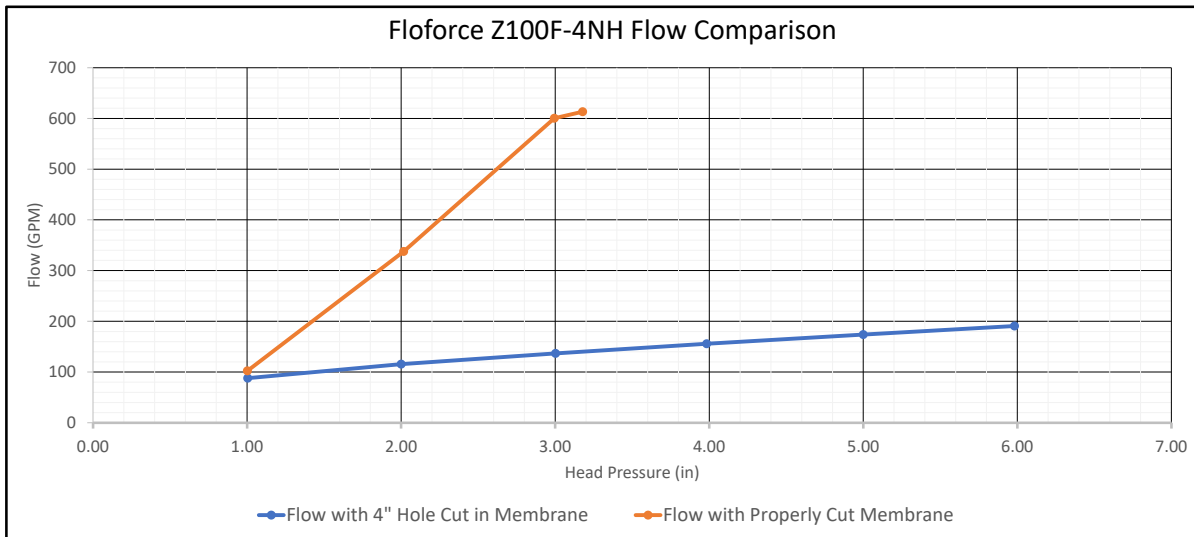
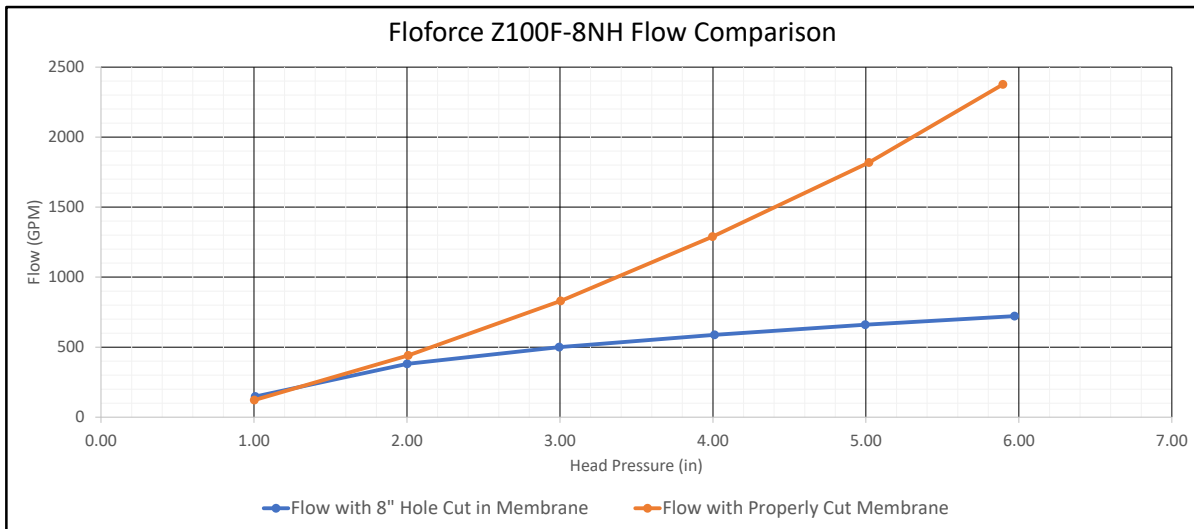
The flow graphs below represent a flow comparison between a properly and improperly cut roof membrane applied to a Z100F FloForce™ drain. The comparisons were conducted utilizing a 4" No-hub and an 8" No-Hub drain outlet. To simulate an improperly cut membrane, a 4" hole was cut into the membrane of the 4" drain sample and flow tested. Likewise, an 8" hole was cut into the membrane of the 8" drain sample and flow tested. The graphs display flow rate of the drain vs. ponding depth of water around the drain, utilizing a 4-ft Sch. 40 PVC vertical outlet drain pipe attached.

Proper roof drain installation is critical to the effects of how a roof drain performs. Specifically, the way the membrane is cut out to leave access to the interior drain body plays a critical role in how the water enters and flows through the drain. An improperly cut membrane can have phenomenal effects on the flow performance of a drainage system.

One common practice during the install of a roofing system is to cut a smaller temporary hole within the membrane, usually the same size as the drainage pipe, and continue the drain install accordingly. When the membrane and drain seal are clamped properly, the installer will sometimes leave the hole in the membrane as it is, with the intention of coming back later to finish cutting the membrane out. This step can oftentimes be forgotten, leaving an improper hole size in the membrane; the effects are devastating to flow performance of the drain.
