Proceptor[®]

Seafood Restaurant's **Grease Clogs** Local Sewer System

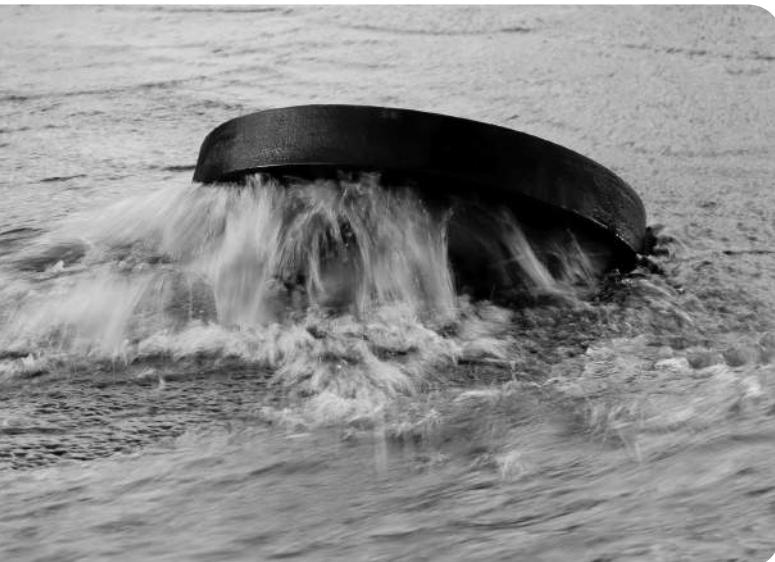
The concrete interecptor failed

The restaurant's grease interceptor was severely corroded and needed to be replaced immediately. Pretreatment authorities confirmed the interceptor failed to meet local effluent "FOG" (fats, oils, grease) standards. They quickly raised flags, citing food grease and solids as the leading cause of sanitary sewer overflow.

The restaurant replaced its concrete interceptor with a Proceptor GMC-2000 fiberglass grease/solids interceptor, by Green Turtle. They chose Proceptor because the system is highly effective, easy to maintain and guaranteed not to corrode. With a 30-year warranty, the Proceptor system was easily installed and a low-cost maintenance plan was designed.
